## HOME:

## Reinforcement Solutions

Baker Aluminum offers comprehensive reinforcement solutions to fortify your carports and other aluminum structures. By enhancing key elements like bracing, beams, and posts with superior materials and design, we provide increased stability and resilience against severe weather conditions.

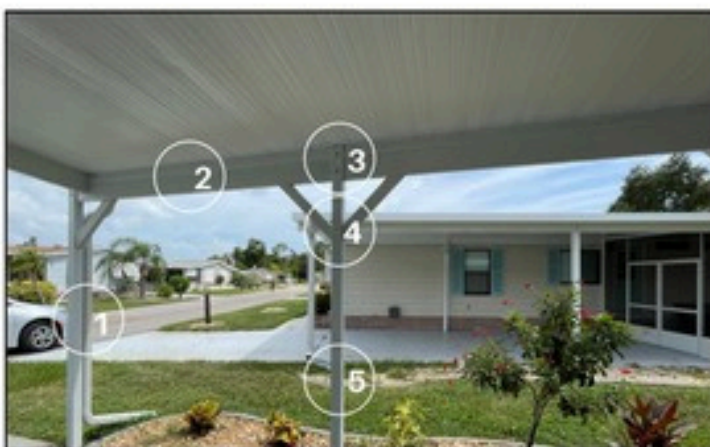
**AFTER**

**3x4 down spouts** (had small 2x3 down spouts before)

**Added 2x6 beam to existing 2x4 beam for additional span strength** (had small 2x4 beam before)

**New 3/8" stainless steel bolts** (had only (1) 1/4" bolt before)

**Added knee bracing for additional stability and strength**

**New 3x3.093 posts** (had thin gauge scalloped posts before)
